RARITAN RIVER BASIN
MATAWAN CREEK, MONMOUTH COUNTY
NEW JERSEY

MATAWAN LAKE DAM

PHASE I INSPECTION REPORT
NATIONAL DAM SAFETY PROGRAM

JULY 1978

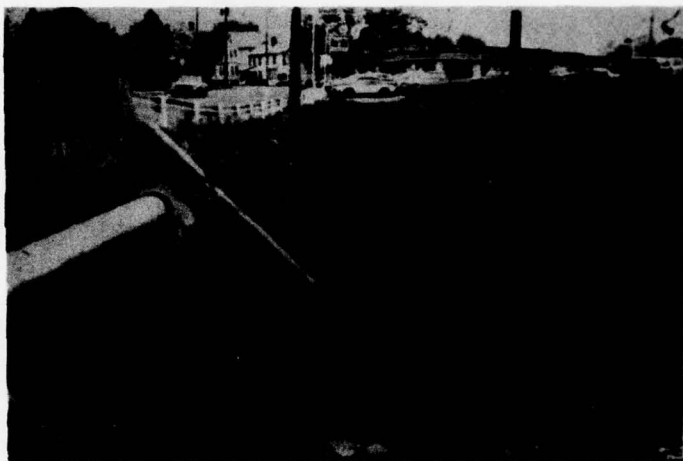
Matawan Lake Dam is in poor overall condition physically. This is primarily related to the condition of the downstream roadway embankment which is overly steep; has its toe ending in the downstream brook channel; and is poorly supported at the top.

Photo 1 - General view of the downstream face of the roadway embankment, looking toward the left abutment

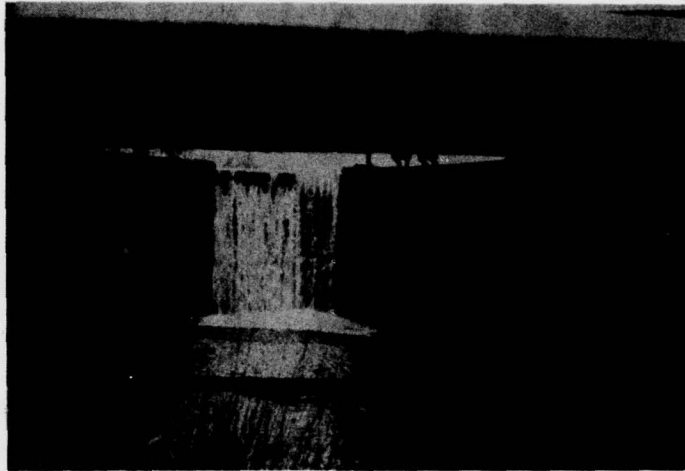
The visible concrete surfaces of the spillway are in fair and acceptable condition with some roughening of the surfaces due to erosion. The spillway crest is smooth and apparently level. The construction joints are tight but show surface cracking. There is some local spalling and deterioration in the formed hole for the 36-inch diameter low level outlet.

Photo 3 - View of the semi-circular weir from downstream showing the low flow notch in the weir; the low level outlet pipe is to the right of the overflow cascade

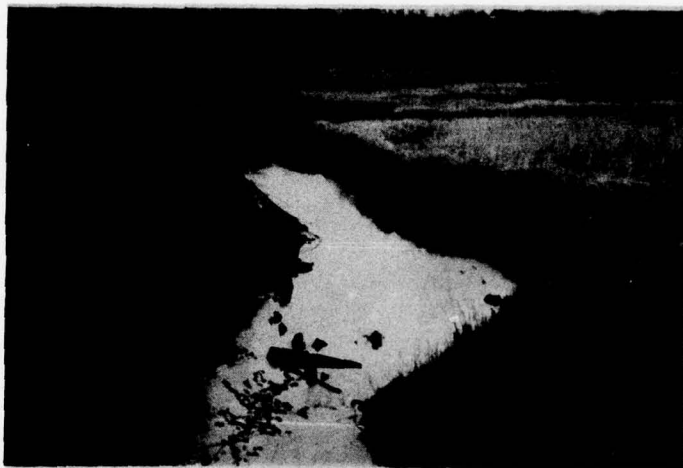
Photo 7 - View of the downstream channel, running parallel at the toe of the left embankment section before turning downstream

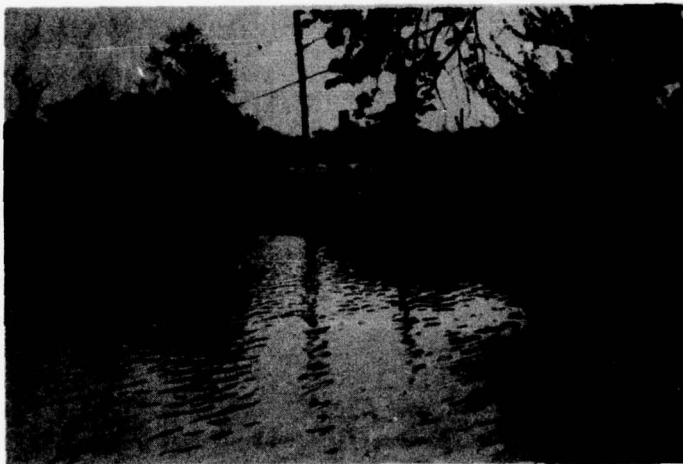
Photo 9 - Upstream view of the roadway embankment and weir, looking toward the left abutment

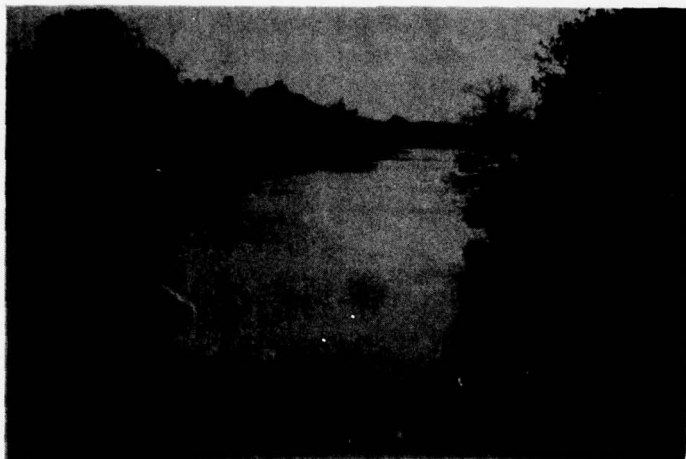
Photo 11 - View of Matawan Lake from the Little Street bridge crossing, looking toward the dam
